N°: 505-06-000020-144

**REQUÊTE POUR PERMISSION D'INTERROGER
LE REQUÉRANT PASCAL DUPUIS ET POUR
PERMISSION D'INTRODUIRE UNE PREUVE APPROPRIÉE**
(Art. 2, 20, 46, 397 et 1002 C.p.c.)

TECHNICAL MEMORANDUM

**Cooling Tower Leak Assessment – PolyOne St. Rémi, Québec**

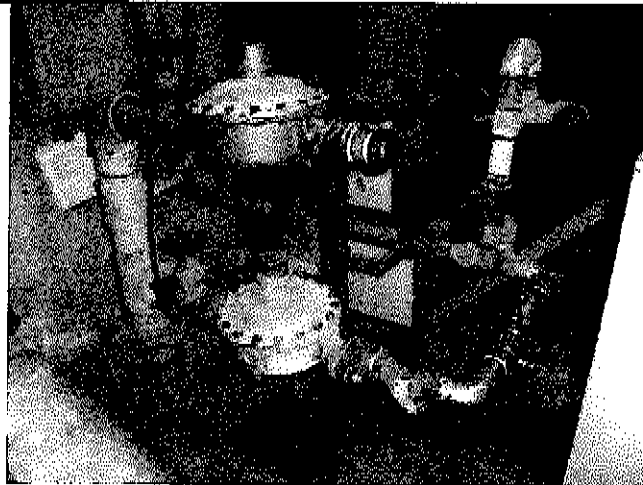
Photo 1 - Main water supply feed and backflow preventer

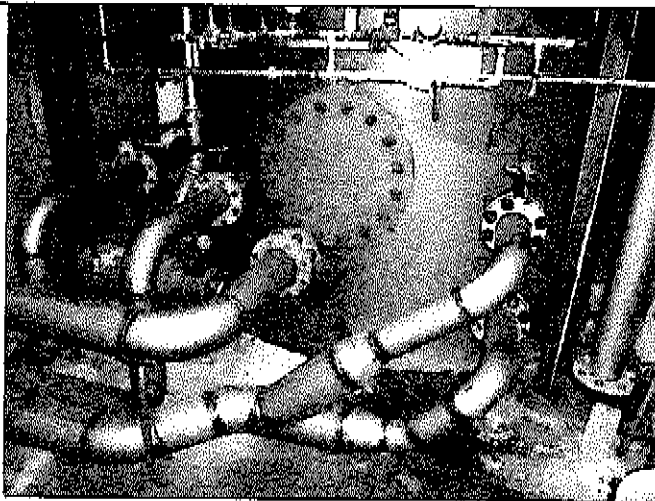
Photo 3 - Plasticizer area water tank - tank bottom

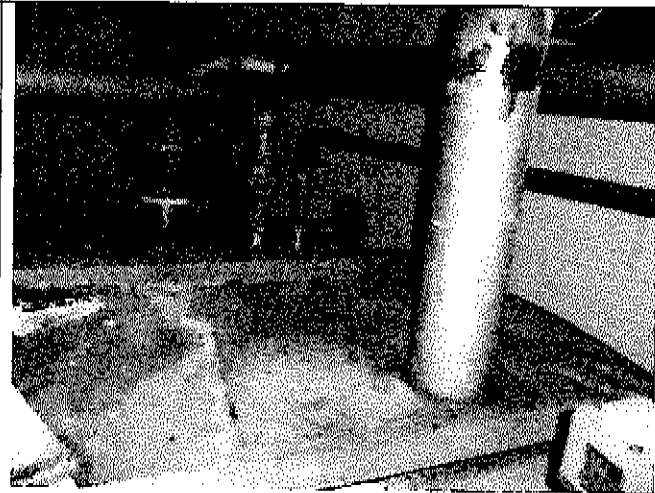
- The water supply feed to the Plasticizer Area tank is through the top of the tank and terminates above the tank's overflow outlet. Therefore, the configuration provides a constant air gap between the maximum water level in the tank and the water supply pipe.

Photo 4 - Plasticizer area water tank - tank top with make-up water piping and process piping

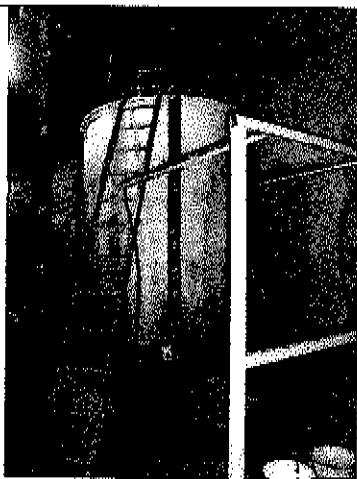
Photo 5 - Flexible area water tank

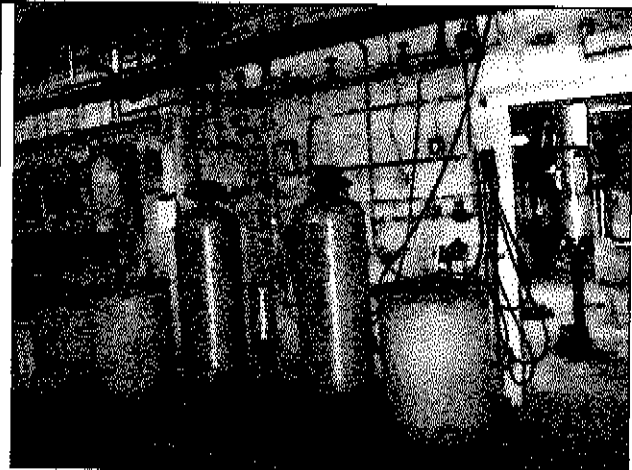
Photo 6 - Softener system

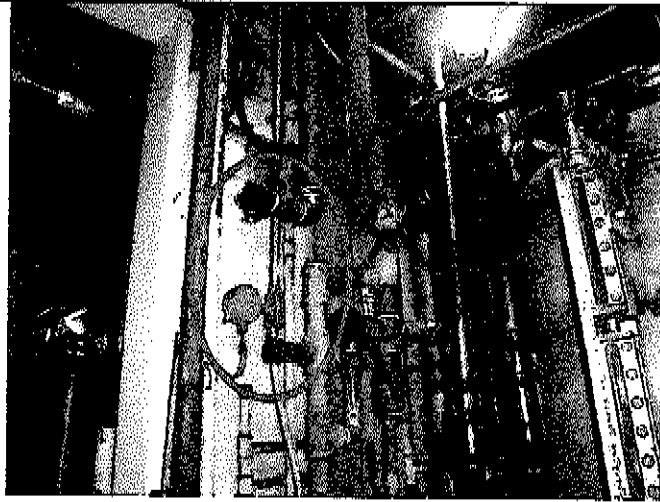
- There isn't a direct connection between the higher process water pressure of 55 psig and the lower water supply pressure of 30 psig (worst case scenario; the water supply pressure reportedly varies between 30 and 60 psig). Facility staff have indicated that the 50 mm Valve B was closed before midnight on 18 December, 2013 as is generally the case during normal operations.

Photo 7 – Location of water supply valve B that was removed. Pipe capped off at both ends.

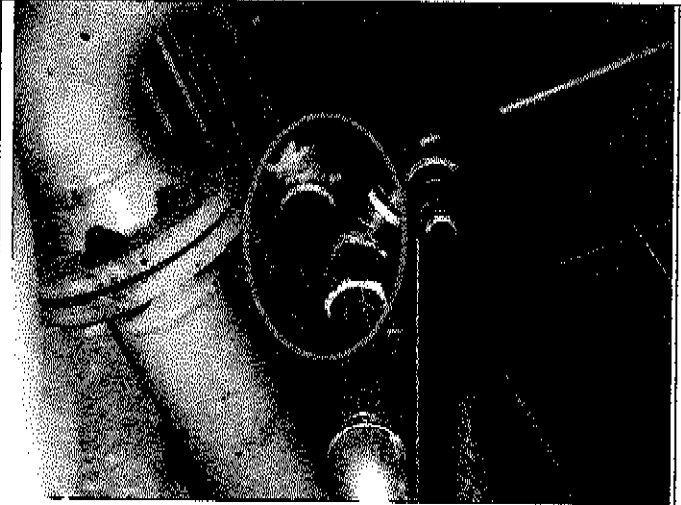
Photo 8 – Location of water supply valve A that was removed. Pipe capped off at both ends.

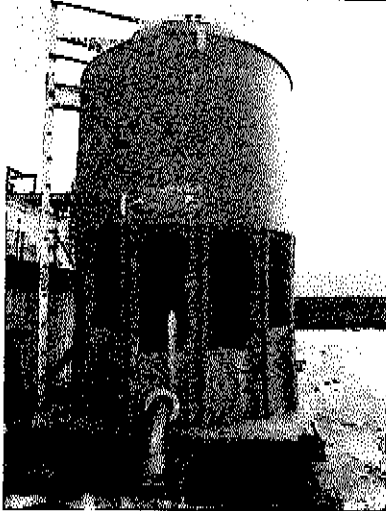
Photo 9 – Cooling tower for plasticizer area.

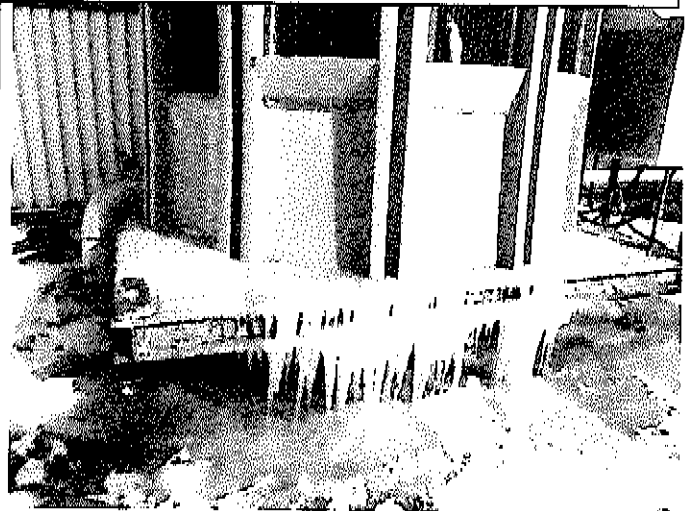
During the January 28-30 2014 inspection of the Plasticizer Area cooling tower, significant icicles were noted at the base of the tower as shown in Photo 10. Also, the roof of the building was covered with ice over a large area from the tower to a roof drain. This is evidence that the cooling tower had been leaking process water onto the roof. The evacuation path for water is through the roof drainage system which discharges to the town of St. Rémi sewerage system. PolyOne provided conductivity tests on water obtained from roof ice between the cooling tower and roof drain, and on ice/snow from other parts of the roof. The results showed elevated conductivity between the cooling tower and roof drain, further suggesting that process water had leaked onto the roof, and ultimately into the sewer.

The leakage of the cooling tower is likely resulting from a blockage of the 200 mm drain exiting the base of the cooling tower. From December 12 to 18, mean daily temperatures ranged from -11.4 °C to -20 °C, with daily lows (excluding wind chill) ranging to -25°C (as reported at by Environment Canada from Montreal's Trudeau Airport

weather station). It is very possible that the combination of very cold temperatures extending over a long period while the cooling tower fan was left in operation could have had a significant effect on the operation of the cooling tower. Note that during the winter, the water typically enters the cooling tower at approximately 4°C and is cooled to around 0°C. As the tower is not insulated, ice could build up as observed in the tower inspection photos. Therefore, it is likely that blockage of the 200mm drain is related to freezing.

Photo 10 – Cooling tower for plasticizer area. Icicles at tower pan and freezing water at plant roof.

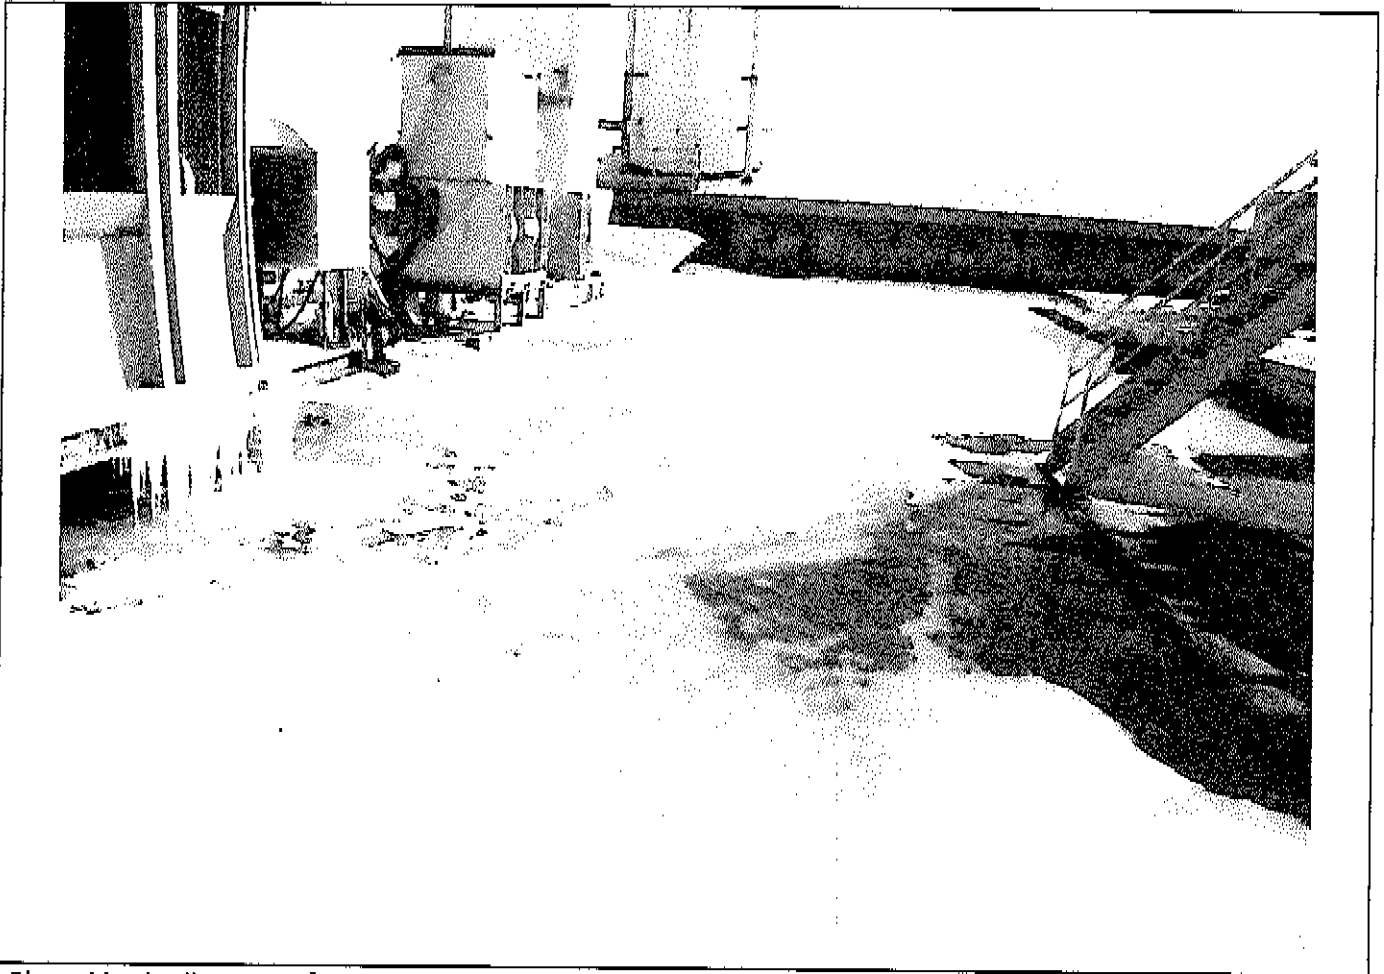
Photo 11 – Cooling tower for plasticizer area. Icicles at tower pan and freezing water at plant roof.

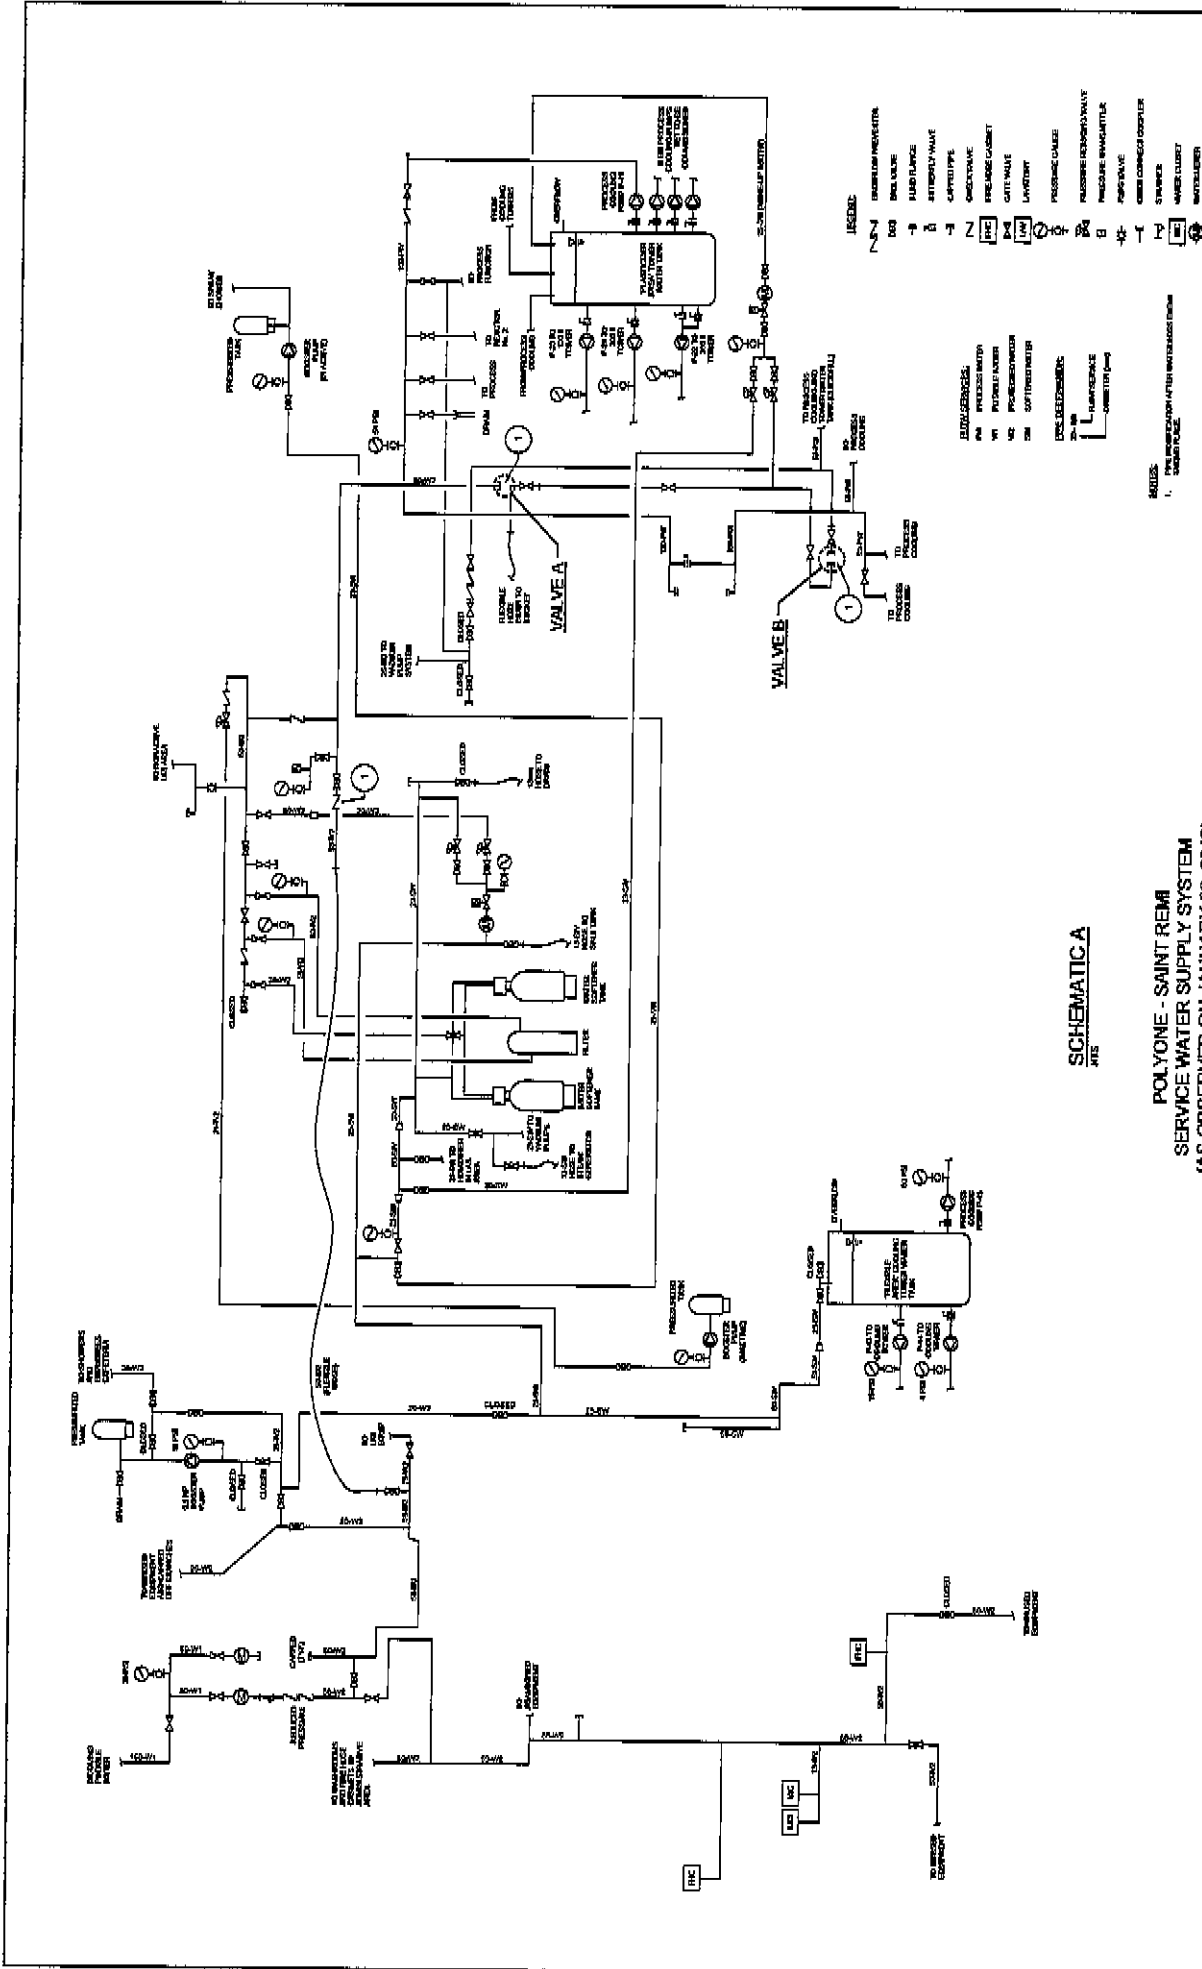
SCHEMATIC A

The service water supply system for the St. Rémi facility as observed during the plant visit is shown in Schematic A. The main supply line is 150 mm diameter. It splits to two 50 mm diameter pipes; one is provided with a reduced pressure backflow preventer and one is capped off. The service water supply piping feeds various fixture units including water closets, lavatories, showers, as well as process systems including vacuum pumps, steam generator, water softener, and two water tanks servicing the facility cooling towers. The water tanks are referred to as the "Flexible Area" water tank and the "Plasticizer Area" water tank. The water loss was observed in the Plasticizer Area water tank on December 18, 2013. Photos of the service water supply system and process systems are shown in the attached Appendix.

The water supply system connects to process systems at various points within the facility as shown in Schematic A. Most connections are not provided with backflow preventers. The connections to the facility Flexible Area and Plasticizer Area cooling tanks are through the roof of the tanks and terminate above the tanks' overflow outlet. As such, an air gap is present which prevents process water from flowing back to the water supply system from the tanks.

However, the 14.1 m³ volume does not include the service water (from the potable water supply) that was admitted manually to the system between 00h00 and 01h00 through the 50mm cross connecting valve (Valve B, see schematic A). This additional volume is not recorded through any plant instrumentation and is not possible to quantify.
